Planat in Action: Accessibility Assessment of UBC Competition and Accommodation Venues for the Special Olympics Canada 2014 Summer Games

Grace Chang & Kristy Tymos | August 1, 2014

Executive Summary

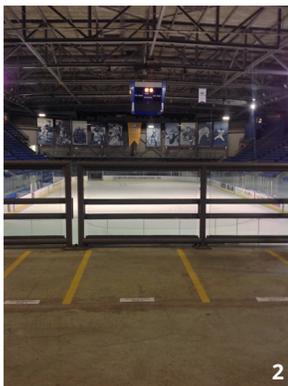
1 Doug Mitchell Thunderbird Sports Centre exterior view
2 Spectators' designated accessible seating area

Designated accessible seating is available level with the rink or overlooking the rink. This seating accommodates companions. At least one percent of the seating is designated as accessible, but if event set-up requires the use of the accessible seating space beside the rink, adequate accessible seating may not be available. Unfortunately, a guard rail installed at an improper height obstructs the view of the rink, which negatively impacts the rating.

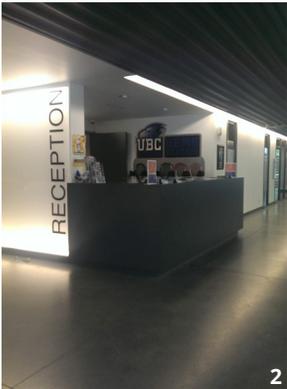
The Tennis Centre enjoys a large foyer with moveable seating and views into the courts. Overall lighting is dim and can be improved for the visually impaired. The service desk is also too high for those in wheelchairs and there is no knee clearance.

- 1 UBC Tennis Centre
- 2 Reception desk and dimly lit foyer
- 3 Unisex single-user accessible washrooms
- 4 Change rooms stalls

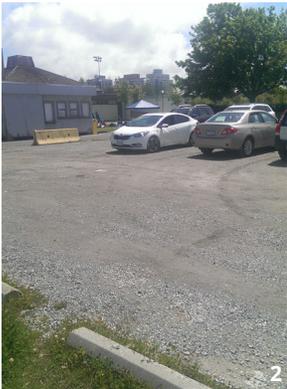
Located at the centre of the complex, the parking lot is paved with gravel, an immediate area of concern for those with disabilities. There is no designated drop-off/pick-up zone. There is also no signage that directs visitors from the main parking lot to the designated accessible parking spots that are located next to the Allan McGavin Sports Physiotherapy Building.

- 1 Thunderbird Fields
- 2 Gravel paved parking lot
- 3 Inaccessible washroom portables
- 4 Change rooms stalls

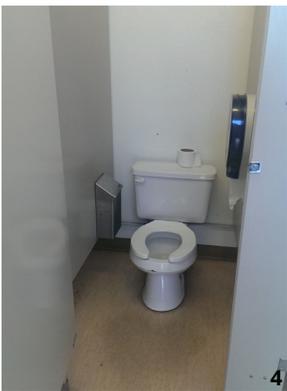
The portable washrooms that serve the sporting fields are accessed through a set of stairs, thus wheelchairs are unable to enter the washroom. The doorway has a threshold too high for a wheelchair to wheel over. Each washroom features three stalls that are too small and pose difficulty for any individual. The washrooms do not reach the accessibility standards in terms of area and heights of fixtures. Signage should exist to direct wheelchair users to the nearest washroom alternative.
